Rochester DX Association

Alpha Adventures - Part I

John “Jack” Kelly WA2CHV

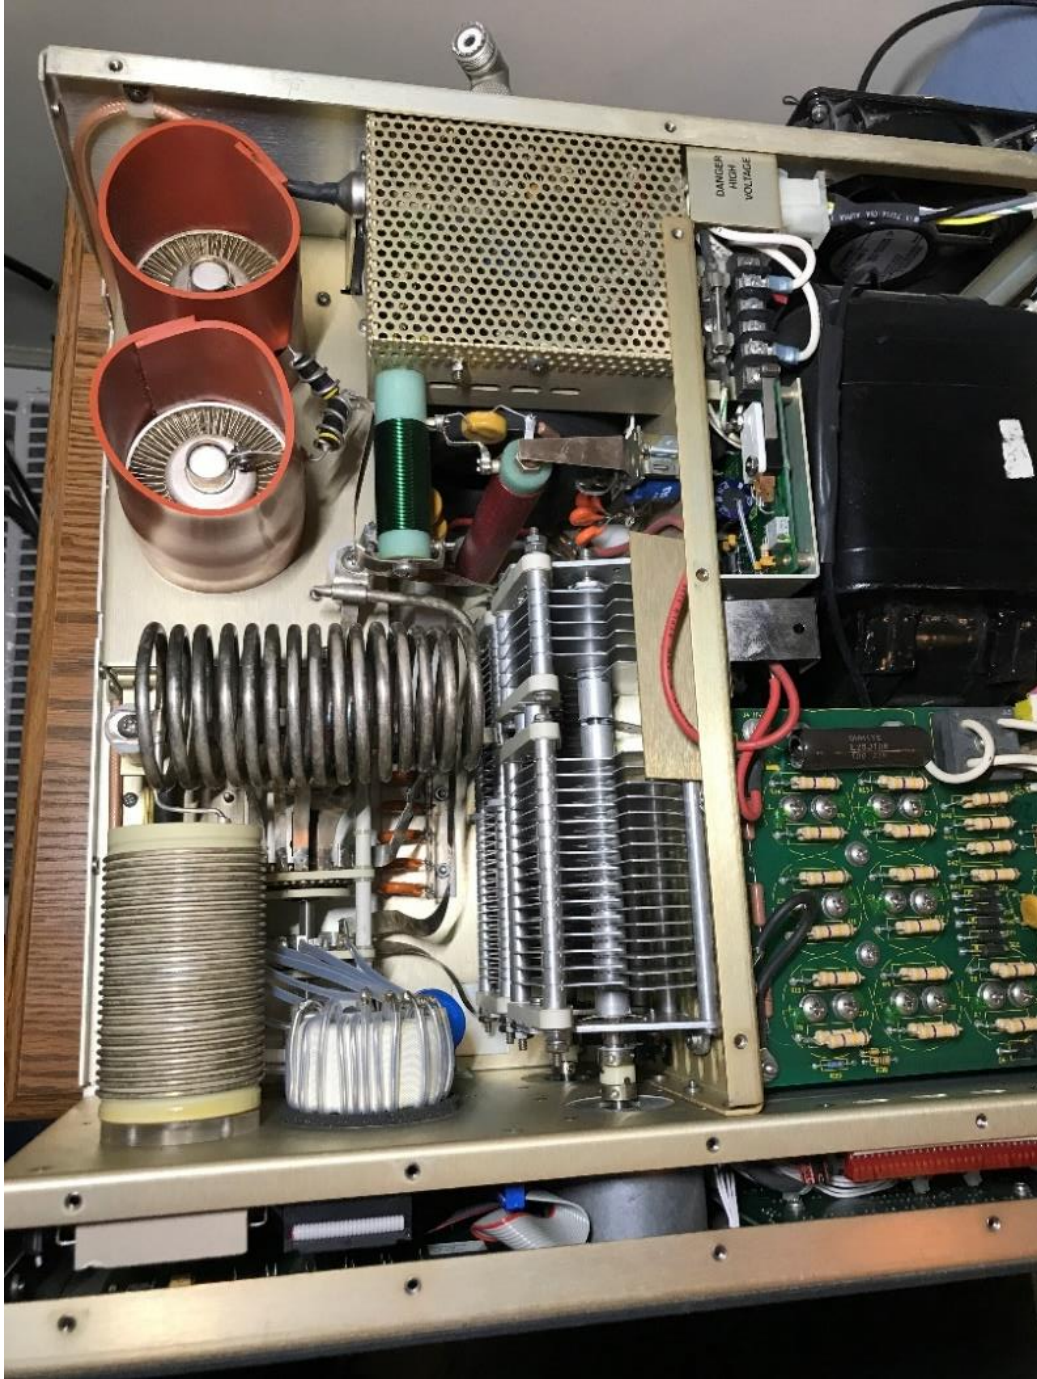
Fig. 3: Interior of the Alpha 87A. RF deck is on the left. The silver plating is tarnished. TUNE capacitor in the middle with the LOAD capacitor underneath it. High-voltage power-supply board on the right. Power transformer in the right rear.

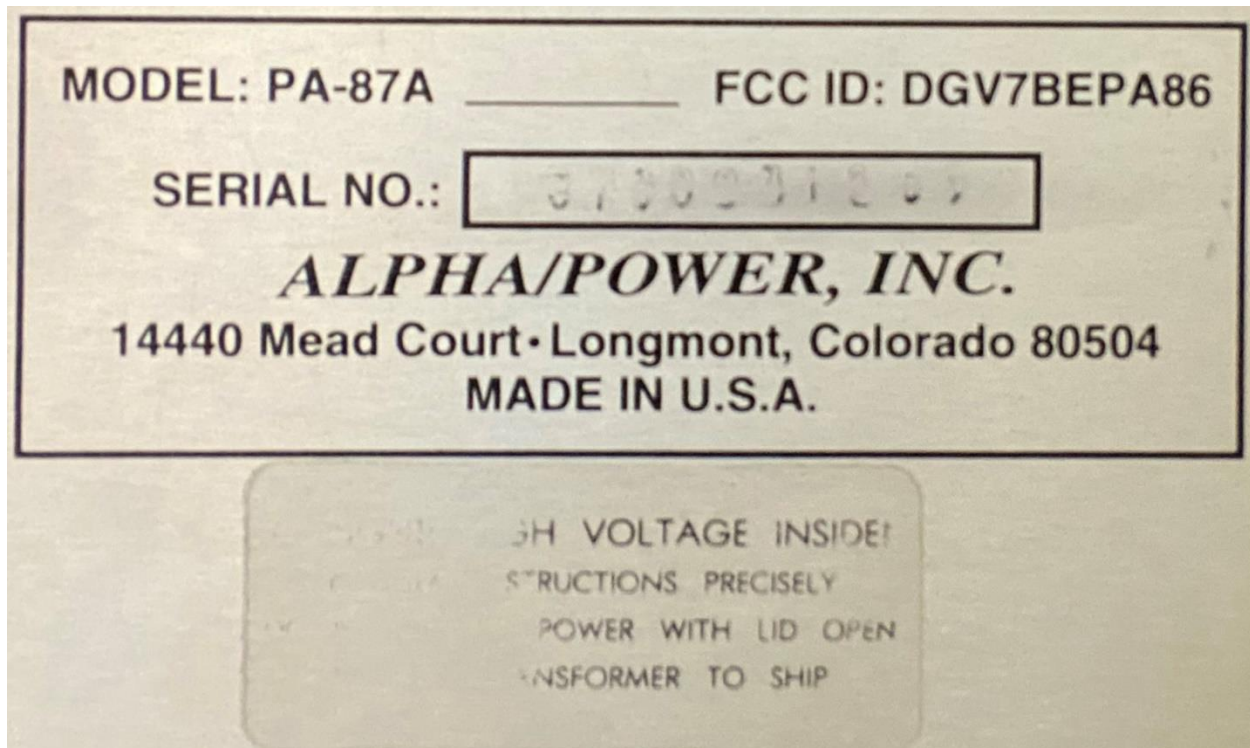
At this point I knew I likely would need experienced help from the current manufacturer's rep. Getting help would require knowing the unit's model number (87A) and the serial number. The serial number was located on the back of the unit and was...unreadable. See Figure 4, below:

Fig. 4: Unreadable serial number on the back of the chassis.

All was not lost. The unit's serial number could be recovered from its microprocessor. All that was required was to establish communication with it over the RS-232 link on the back of the chassis. Happily, the shack computer was old enough to have a DB-9 RS-232 connector. The ancient⁴ Windows HyperTerminal application that Alpha manual recommended was also

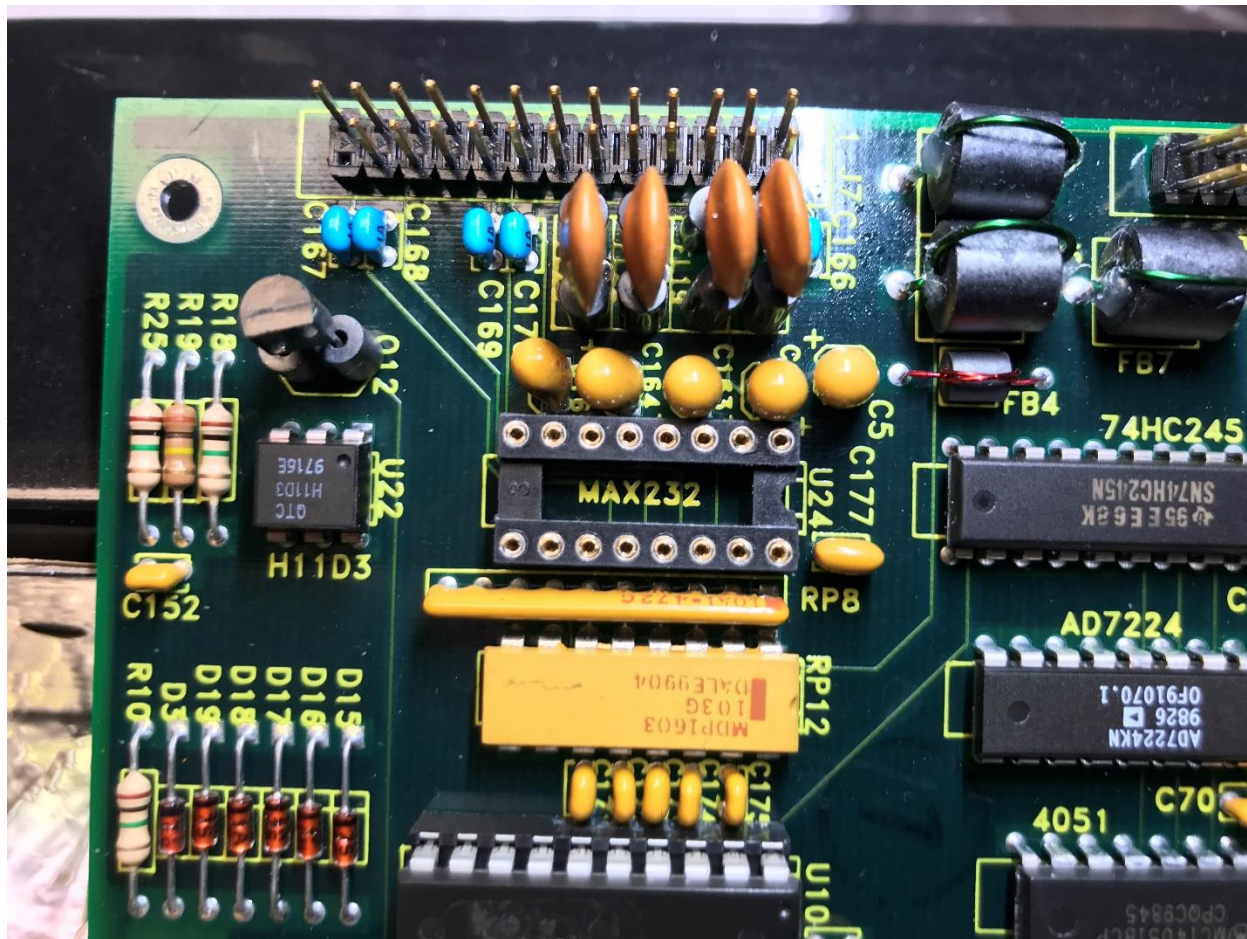
The MAX232 chip is a 14-pin DIP package directly soldered into the microprocessor motherboard in the front of the amplifier. The microprocessor motherboard is a 6-layer circuit board made of the finest Unobtainium⁵. While a new MAX232 chip in a 14-pin DIP package is plentiful and inexpensive, an investment had to be made in a Yihua hot-air rework station to safely and cleanly extricate the dead chip. The motherboard was removed from the amplifier, the chip was removed from the motherboard without damage, and was replaced with a machine-turned, gold-plated, 14-pin DIP socket. Isopropyl alcohol cleaned the solder flux and sweat of my brow that had contaminated the motherboard. See Figure 5, below. A new MAX232 was inserted in the socket.

Fig. 5: New MAX232 chip’s machine-tooled, gold-plated socket installed on the microprocessor motherboard.

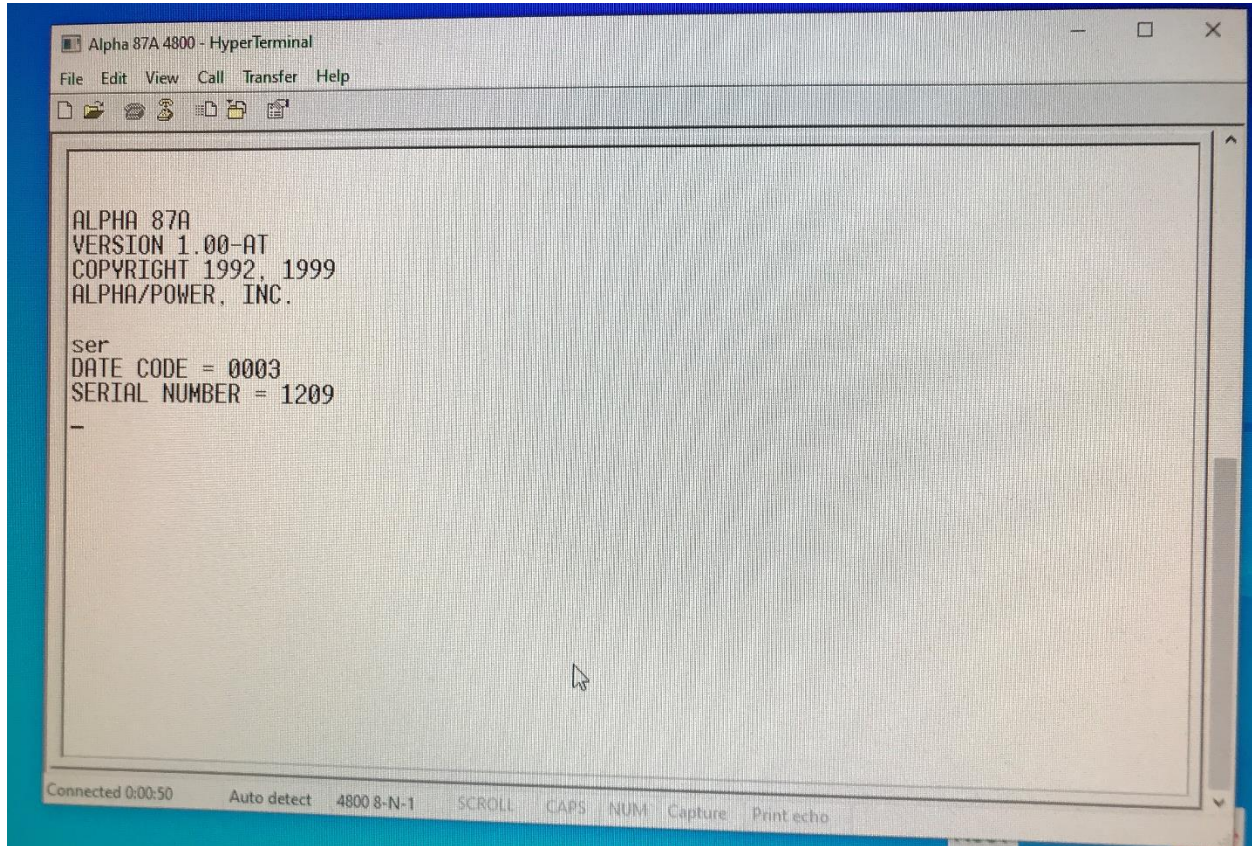
With the motherboard reinstalled, RS-232 communication with the Alpha was readily established. See Figure 6, below:

Fig. 6: First RS-232 communication from the Alpha 87A, serial number 1209.

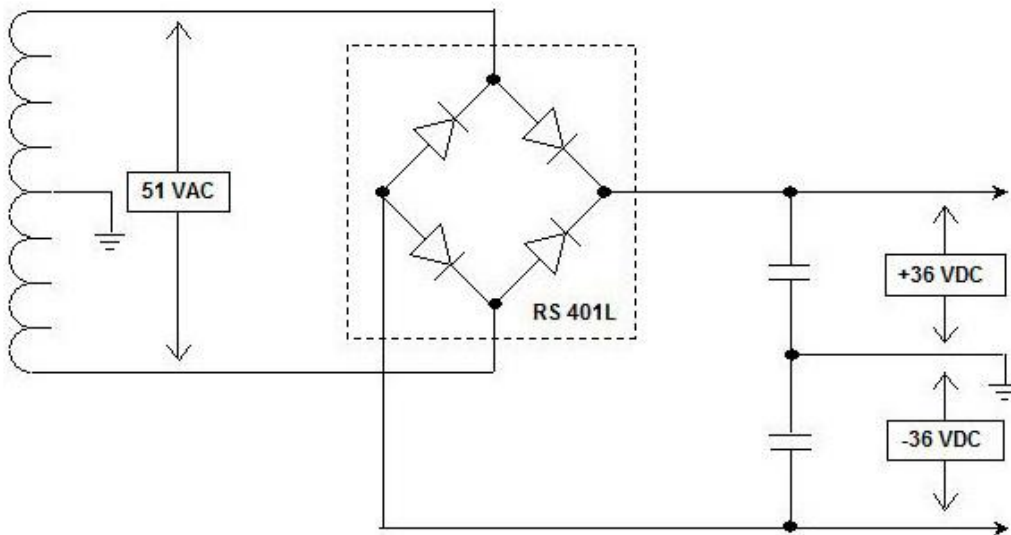
Returning to the original missing voltage problem, the low-voltage power supply board was removed from the chassis for bench testing. Ohm-meter checks revealed that at least one diode in the full-wave bridge supplying the 36 volts was shorted. A simplified schematic of this section of the low-voltage power supply is shown in Figure 7, below:

Fig. 7: Simplified low-voltage power supply schematic

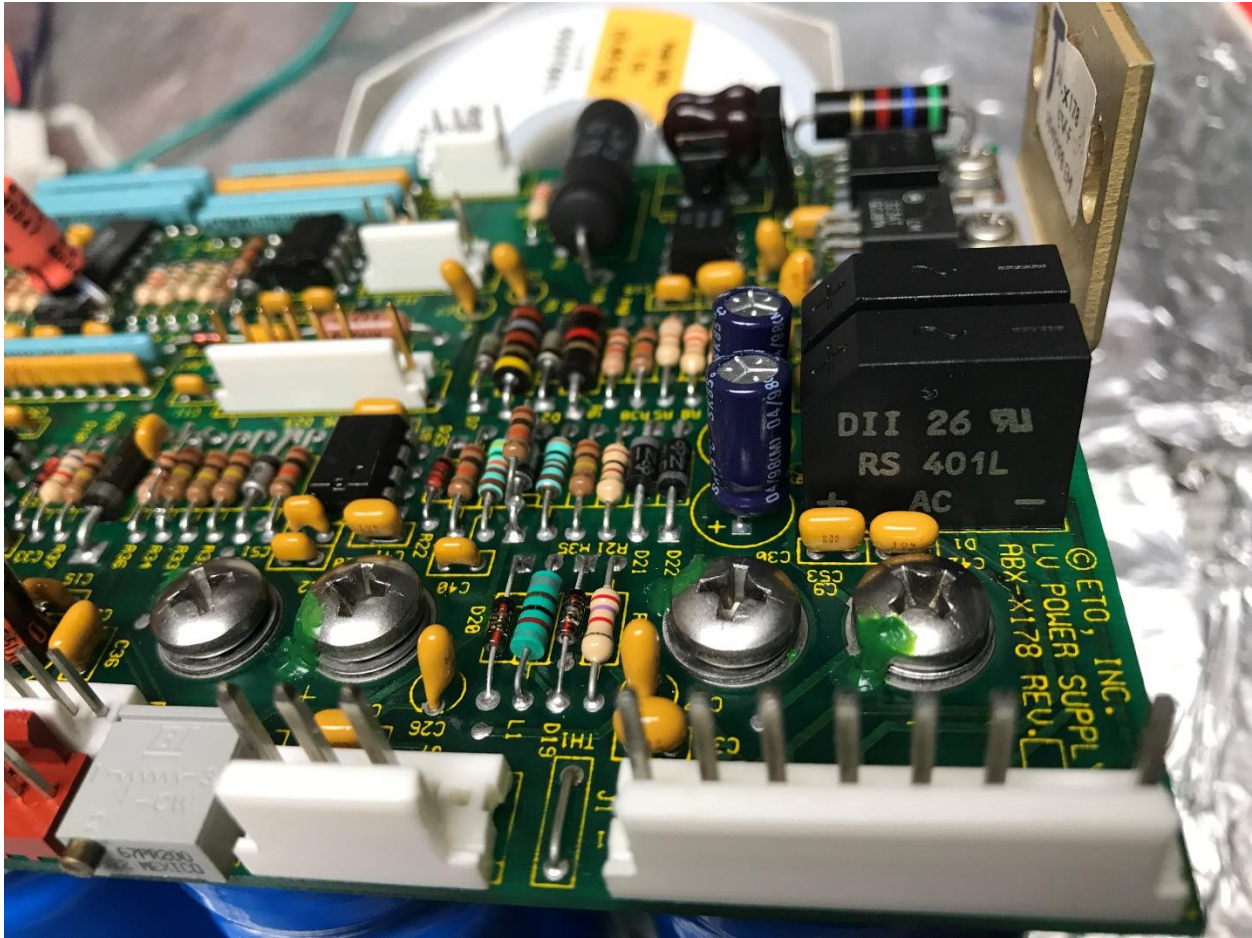
The power supply develops ± 36 VDC from a center-tapped 51 VAC secondary on the main power transformer. The RS 401L full-wave diode bridge in this circuit has a peak reverse voltage rating of 50 volts. Each diode in this circuit sees $1.4 \times 51 \text{ VAC} = 71$ reverse volts! I don't know how this diode bridge survived in this amplifier for so long. The RS 401L bridge was replaced with a RS 403L bridge having the same current rating but a peak reverse voltage rating of 200 volts in the exact same package. Removing the failed unit from the circuit board was extremely difficult because it was nestled against another diode bridge, some capacitors, and it had heavy 16-gauge leads. It was impossible to grip the bridge's case to pull it from the board while heating all four leads simultaneously. See Figure 8, below:

Fig. 8: The failed RS 401 L on the low voltage power supply board.

Eventually I resorted to very carefully drilling through the case to remove it in pieces. Unfortunately, the adjacent electrolytic capacitor was also drilled. A replacement electrolytic was also ordered and soldered in. The low voltage power supply board was reinstalled into the Alpha's chassis.

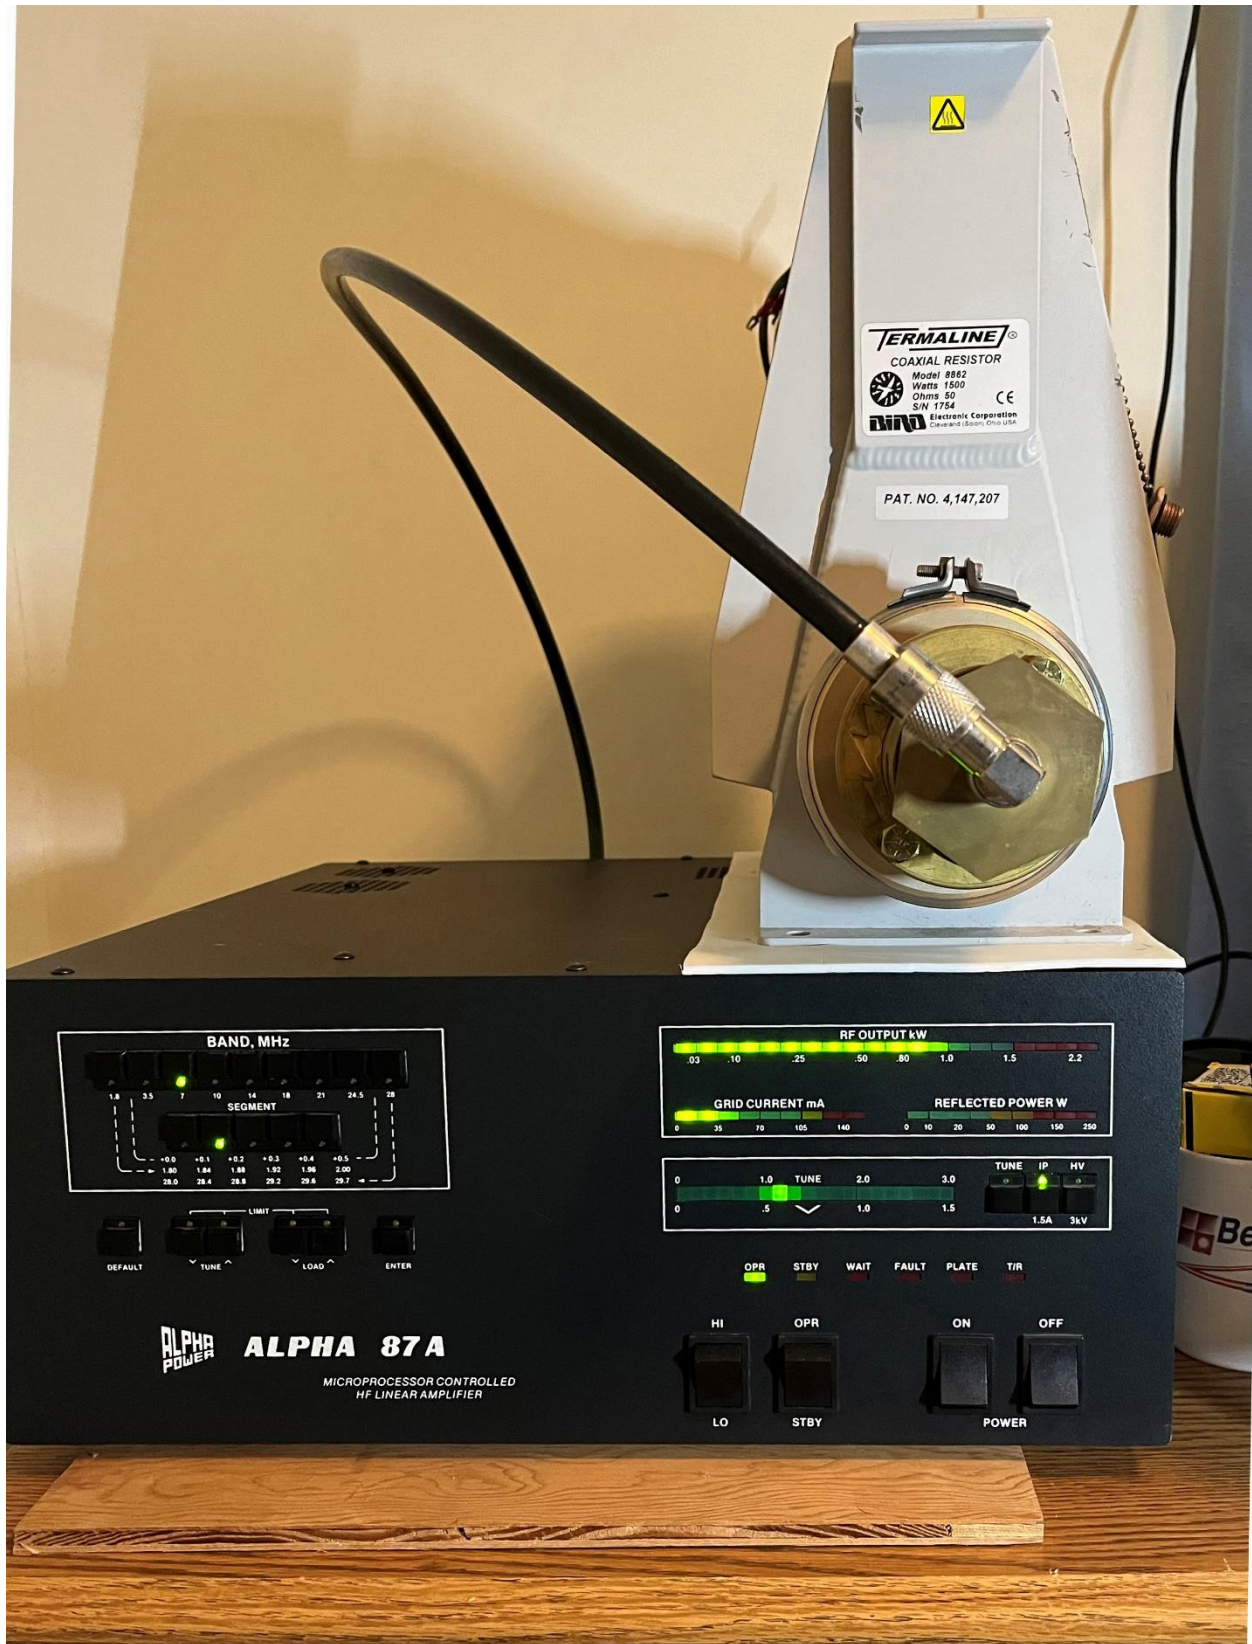
I powered up the repaired Alpha 87A and again watched it successfully sail through its power-on sequence. Going into OPERATE mode, I applied drive to the Alpha. After tuning at a drive of 32 watts to the amplifier, I noted that it made about 1,000 watts output power on 40 meters. See Figure 9, below:

Fig. 9: The Alpha 87A finally making power during tune-up.

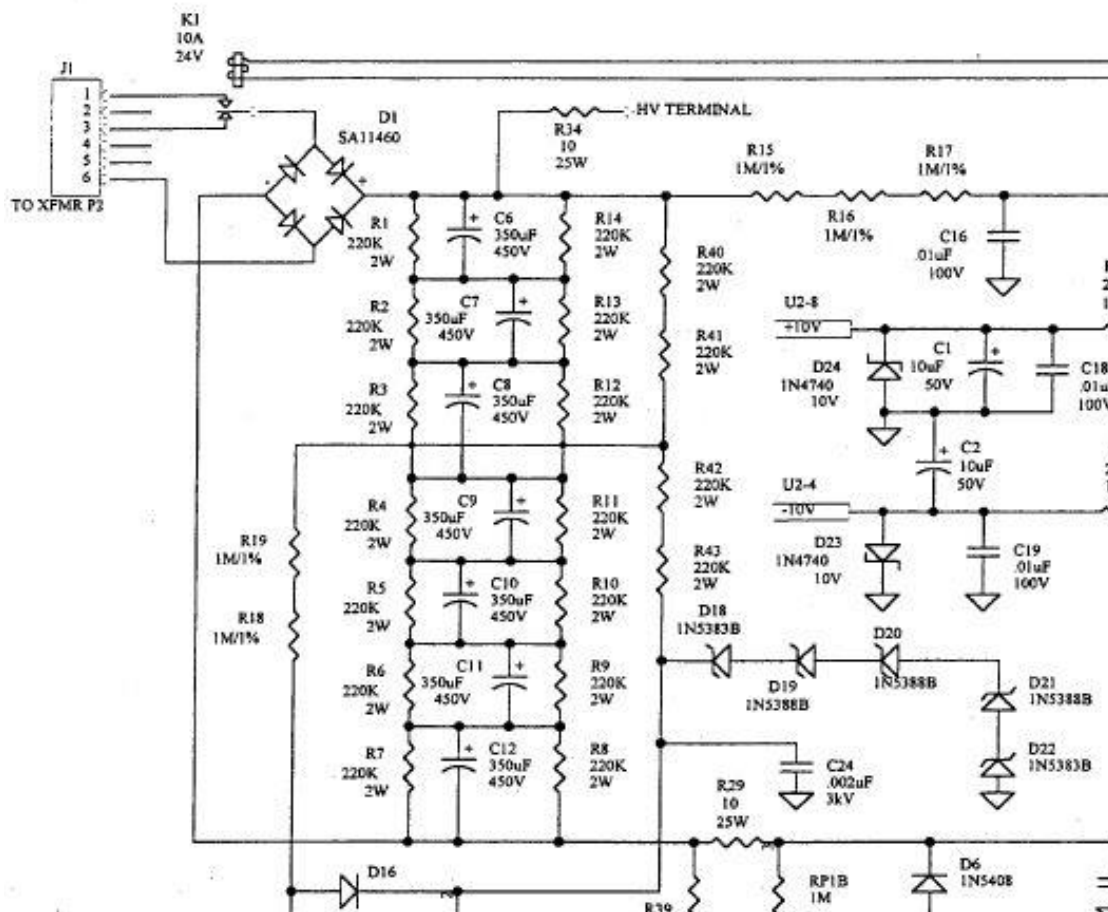
For soft fault 1, the very first step of the diagnostic procedure was to check the receive diode reverse bias power supply voltage. It should have been 900 volts in OPERATE mode. The Alpha had essentially zero volts. The 900 volts is derived from the 3 kV plate supply through a five Zener diode (D18-D22) – four resistor (R40-R43) chain on the high-voltage power-supply board as shown in Figure 10, below:

Fig.10: Receive QSK PIN diode 900 V reverse bias supply schematic. It consists of a chain of five Zener diodes (D18-D22) and four resistors (R40-R43).

Working backwards up the resistor chain starting at R43 up to R40 with a voltmeter revealed that resistor R40 was open. R40 was at the high-voltage end of the chain and was a carbon-film resistor. I had previously encountered carbon-film resistor opening failure due to corona discharge but never at the relatively low voltage of 3 kV. The high-voltage power-supply board was removed from the chassis. A new 2W carbon-film resistor was ordered and soldered in. The repaired high-voltage power-supply board was reinstalled into the Alpha's chassis.
