Rochester DX Association

Alpha Adventures - Part I

John “Jack” Kelly WA2CHV

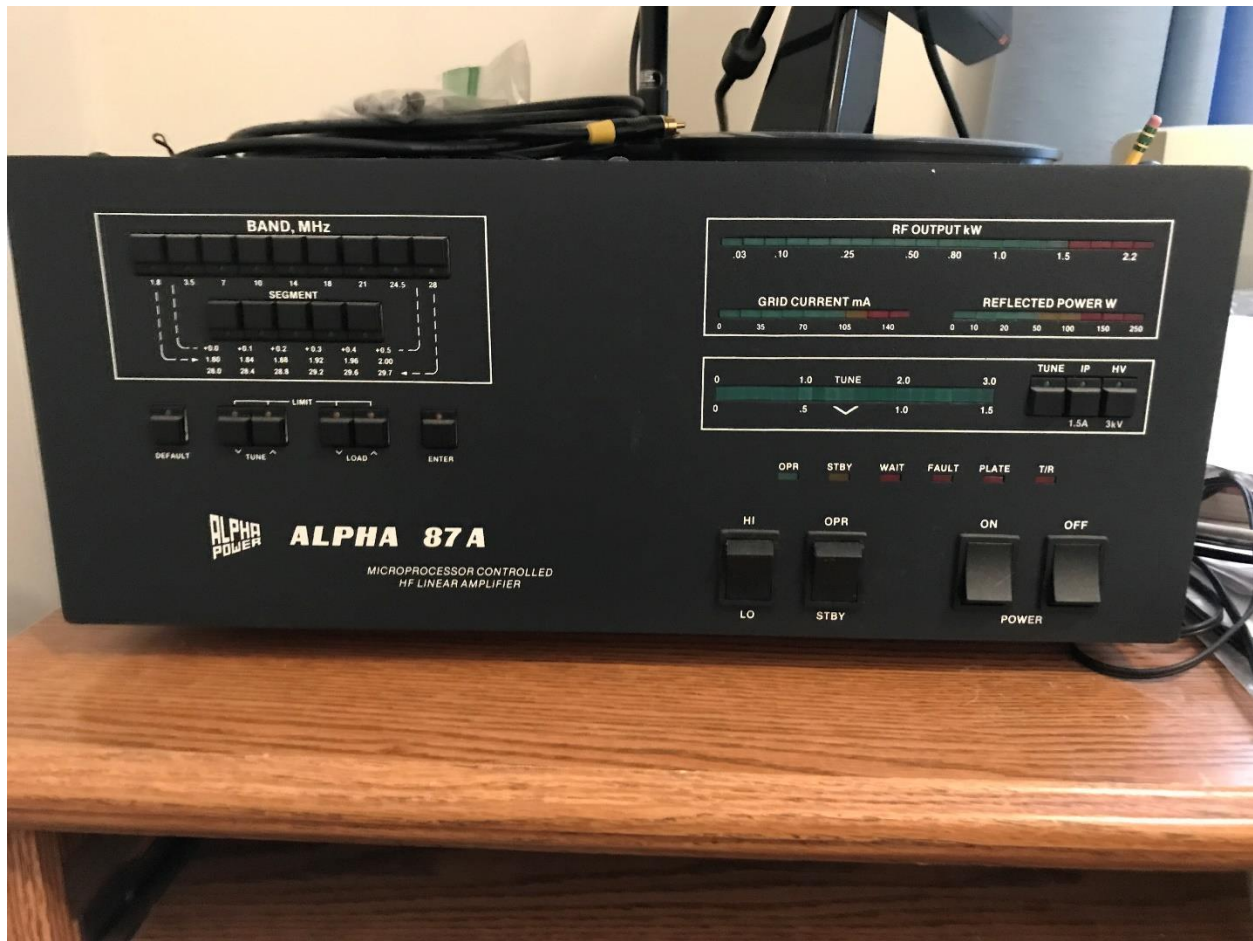
Fig. 2: The Alpha 87A on a desk at WA2CHV. Note the lack of “TUNE” or “LOAD” control knobs on the front panel. The TUNE and LOAD capacitors are adjusted via stepper motors and front-panel switches.
